Benchmark Home Inspections
BENCHMARK HOME INSPECTIONS Inc.
Georgetown, Ontario L7G 5R9
WETT Inspector Licence #9589

726 Coulson Ave
Milton, Ontario

Marginal Summary

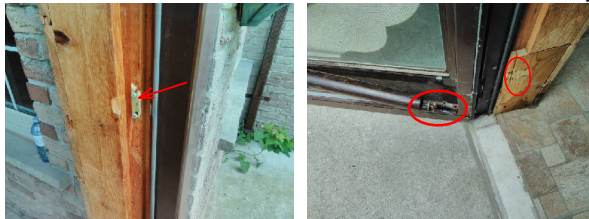
Entry Doors: Metal. The latch is missing and the closer is disconnected on the screen door. Recommend repair.

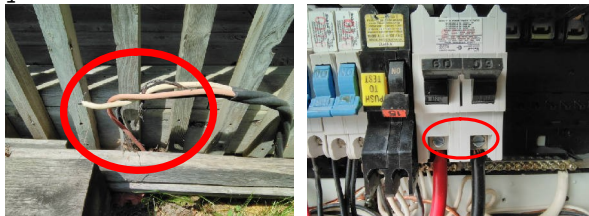
Exterior Electric Outlets: 110 VAC GFCI. A disconnected hot tub circuit is still connected to the breaker. Disconnect the feed from the power source to prevent accidental power up and live conductors in the yard.

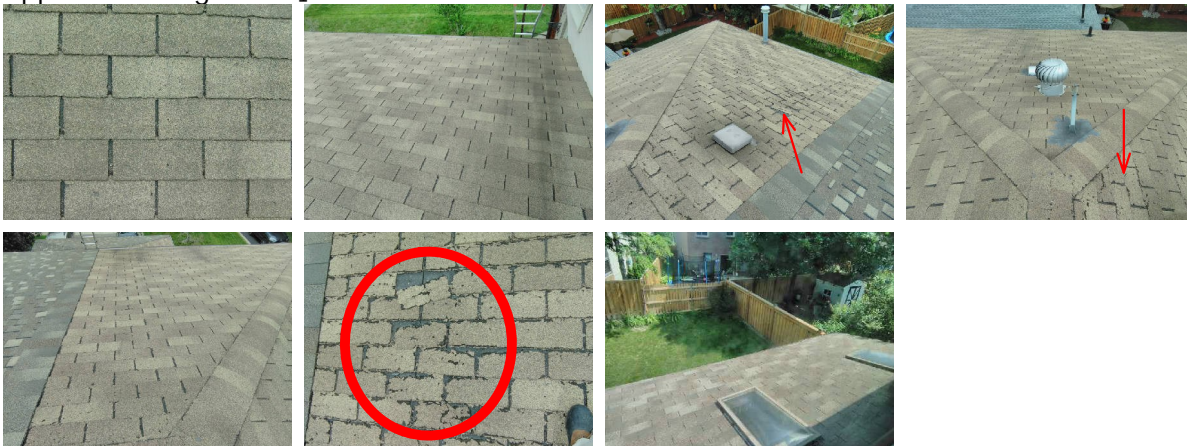
1. Method of Inspection: On roof
2. Acceptable Unable to Inspect: 10%
3. Defective Material: Asphalt shingle. The roof covering appears to be at the end of it's useful life. Replacement will be required.
4. Type: Gable
5. Approximate Age: 15 years

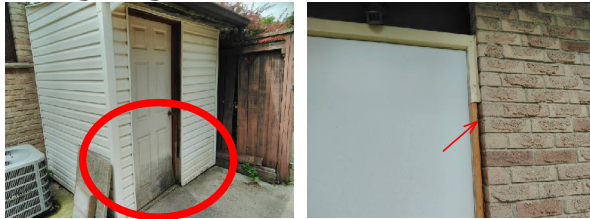
1. Type of Structure: Attached Car Spaces: 1
2. Acceptable Garage Doors: Metal
3. Acceptable Door Operation: Mechanized
4. Acceptable Door Opener: Chamberlan
5. Acceptable Exterior Surface: Brick veneer
6. Acceptable Roof: Asphalt shingle
7. Defective Service Doors: Metal, Wood. The shed door is not intended for outdoor use. Severe water damage noted. Recommend Replacement. The garage service door is missing flashing. Recommend repair.

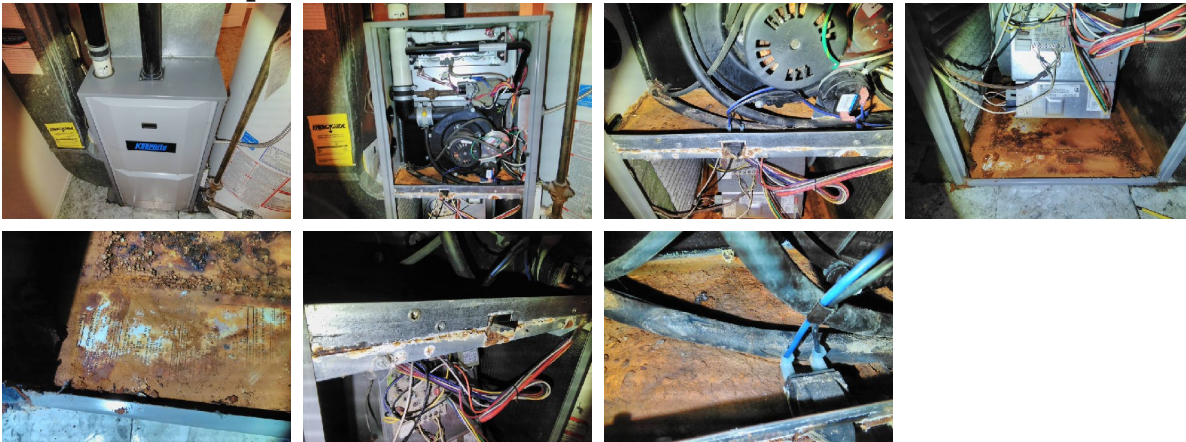
Heating System Operation: Functional. Water damage noted inside the cabinet. A condensation removal hose has split in several places and caused a leak. Recommend having the furnace serviced by a qualified HVAC technician.

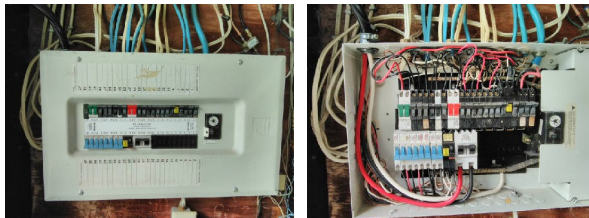
12. Defective Breakers: Copper. Double taps are present at breakers. These circuits need to be moved to their own circuit breaker and cannot share a breaker. It is recommended that a qualified electrician inspect the new circuits and properly connect the new circuits to an individual breaker for each circuit

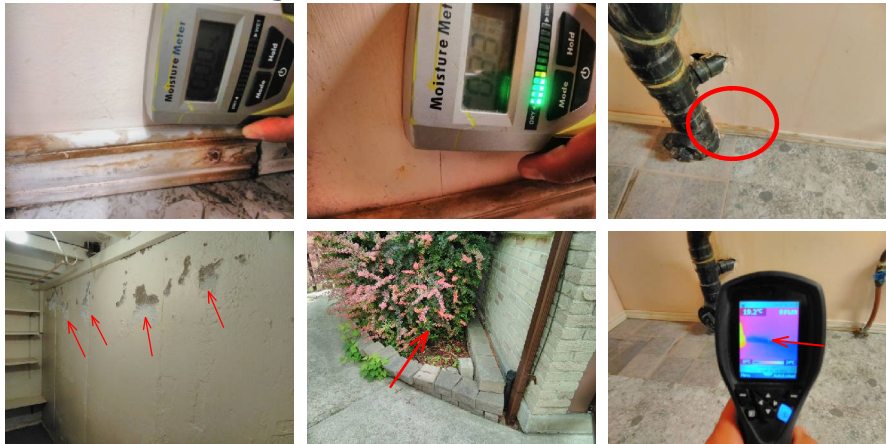
14. Marginal Moisture Location: wall. Water stains present, moderate moisture levels found near the drain stack. Suspect the cause is a slight leak from the drain line to the foundation. Recommend further investigation. Efflorescence noted in cold cellar. Suspect the garden outside may hold moisture against the cold room foundation walls. Recommend further investigation.

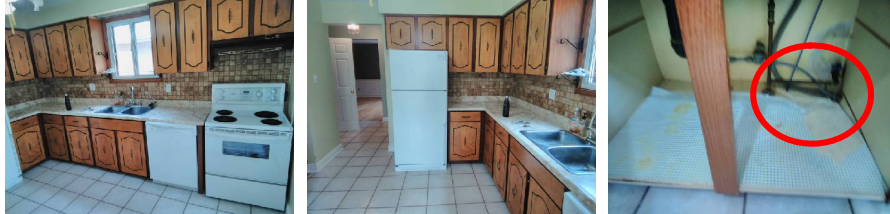
Cabinets: Wood. Water damage noted under the sink cabinet. Recommend repair. No active leaking was noted during the inspection.

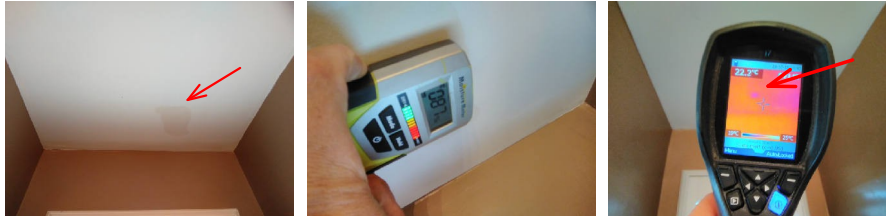
1. Marginal Ceiling: Paint. Evidence present water staining. Active leak detected. Repairs required.

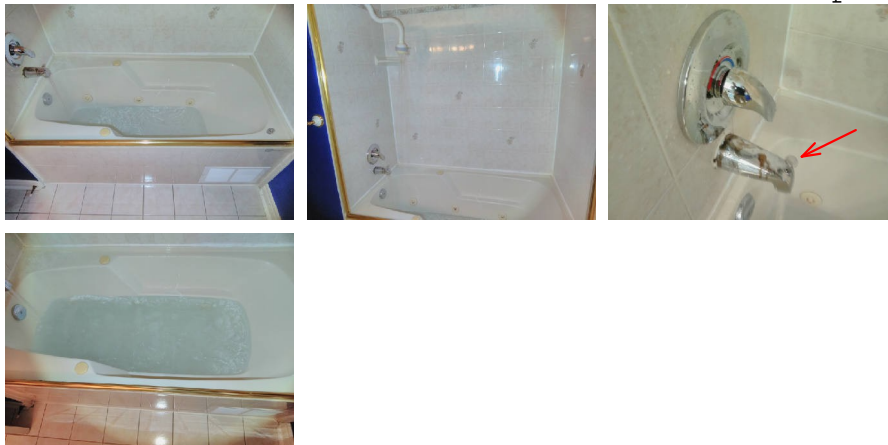
- 20. Acceptable Faucets/Traps: Metal fixtures with a ABS trap
- 21. Marginal Tub/Surround: Fiberglass tub and ceramic tile surround. The tub spout diverter handle is seized closed. Recommend Replacement.

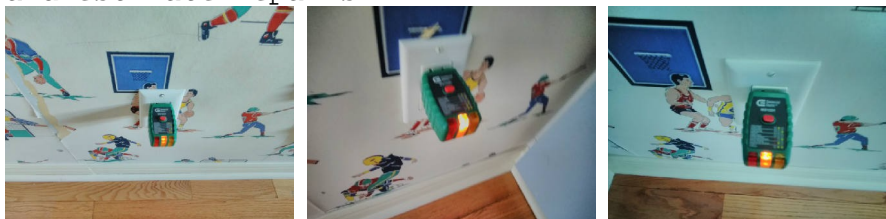
- 6. Acceptable Windows: Vinyl casement, Aluminum slider
- 7. Defective Electrical: 110 VAC. A licensed electrician is recommended to evaluate and estimate repairs

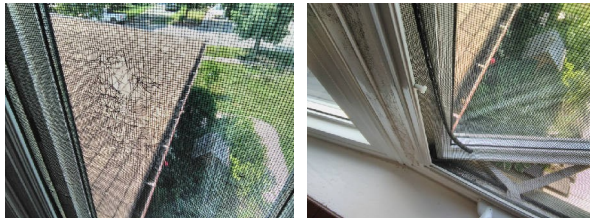
15. Marginal Windows: Vinyl casement, Aluminum slider. The casement windows have a damaged screen and loose weatherstripping. Recommend repairing the window components to reduce drafts and keep pests outside of the home.

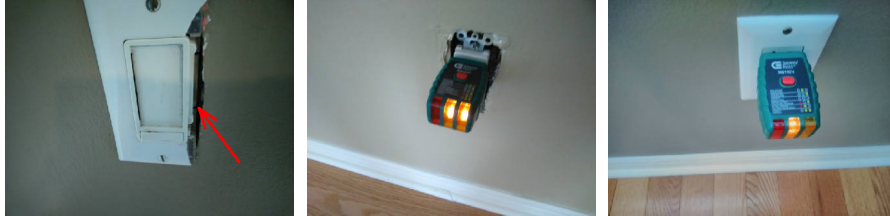
25. Defective Electrical: 110 VAC. The slide for the outlet is missing. Recommend Replacement.
