Benchmark Home Inspections
BENCHMARK HOME INSPECTIONS Inc.
Georgetown, Ontario L7G 5R9
WETT Inspector Licence #9589

726 Coulson Ave
Milton, Ontario

Marginal Summary

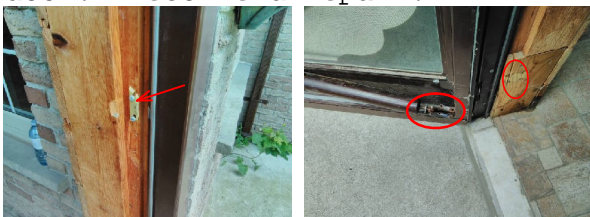
5. Entry Doors: Metal. The latch is missing and the closer is disconnected on the screen door. Recommend repair.

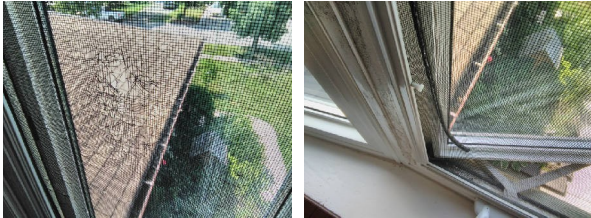
16. Bedroom 2 Bedroom Windows: Vinyl casement, Aluminum slider. The casement windows have a damaged screen and loose weatherstripping. Recommend repairing the window components to reduce drafts and keep pests outside of the home.

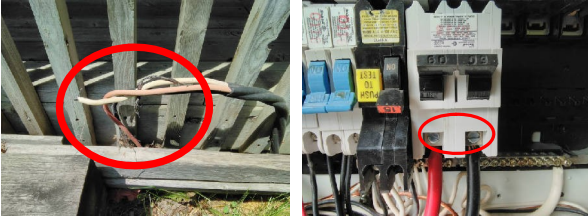
1. Exterior Electric Outlets: 110 VAC GFCI. A disconnected hot tub circuit is still connected to the breaker. Disconnect the feed from the power source to prevent accidental power up and live conductors in the yard.

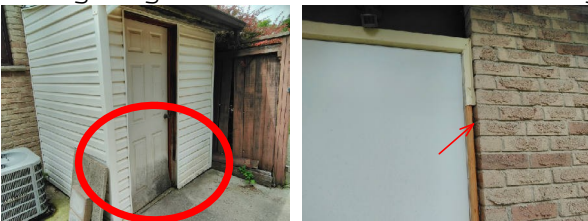
3. Attached Garage Service Doors: Metal, Wood. The shed door is not intended for outdoor use. Severe water damage noted. Recommend Replacement. The garage service door is missing flashing. Recommend repair.
